# BI-DIRECTIONAL ISOLATOR RELAY DELAY Diesel-2 Service Manual

## Product Description

The BIRD (BI-DIRECTIONAL ISOLATOR RELAY DELAY) performs two important functions. It provides a method of charging the coach battery from the engine alternator and charges the chassis battery from the converter when the coach is plugged into shore power.

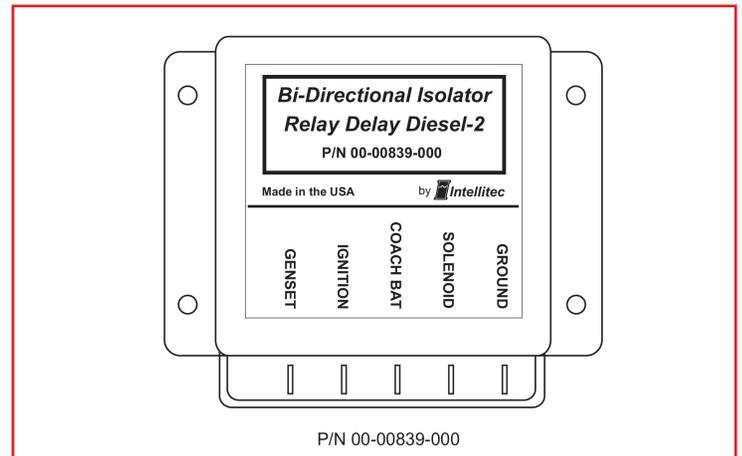
The BIRD operates in conjunction with a continuous duty solenoid to provide the isolator/battery charging functions of a motor home. It senses voltage on the coach and chassis batteries. If the voltage on either one is above 13.3 volts, indicating the battery is being charged, it closes the isolator relay, paralleling the batteries, charging both. It operates in two directions, charging the batteries from the engine alternator and charging the batteries from the converter. These functions are similar but operate at different thresholds.

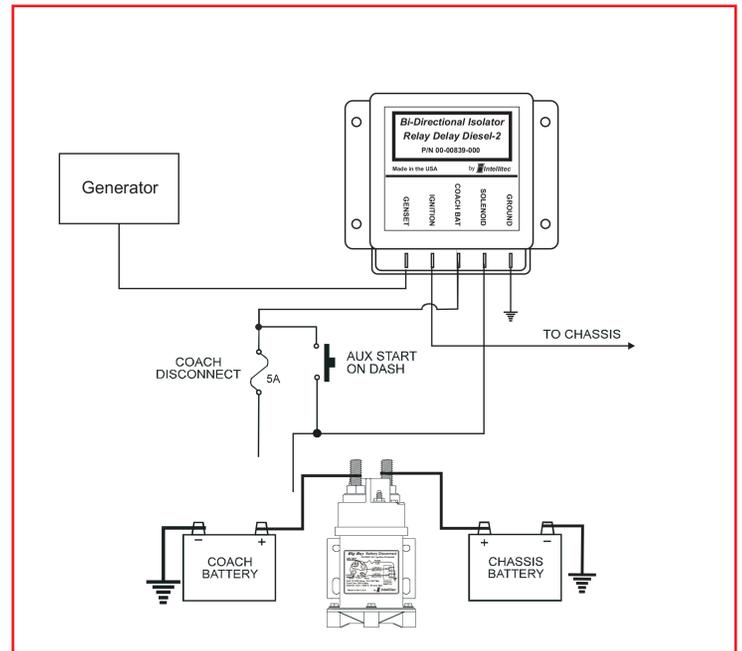
Typical Installation Diagram

When the generator is operating, a 12 volt signal is applied to the generator input. This inhibits the isolator from operating. This is to prevent the generator/converter combination from supplying power to the chassis functions which might over-load the converter or the generator circuit breaker.

The unit is housed in a plastic enclosure suitable for mounting under the hood, out of direct water spray. It operates in combination with a continuous duty solenoid to connect the two batteries at the proper times for charging.
